Aquatic Diving & Marine Services Company

Ref No: ADMSC/MPT-31/10-15/62

SUB :- UNDERWATER INSPECTION OF SUNKEN VESSELS WRECKAGES AT INNER ANCHORAGE, MORMUGAO HARBOUR GOA.

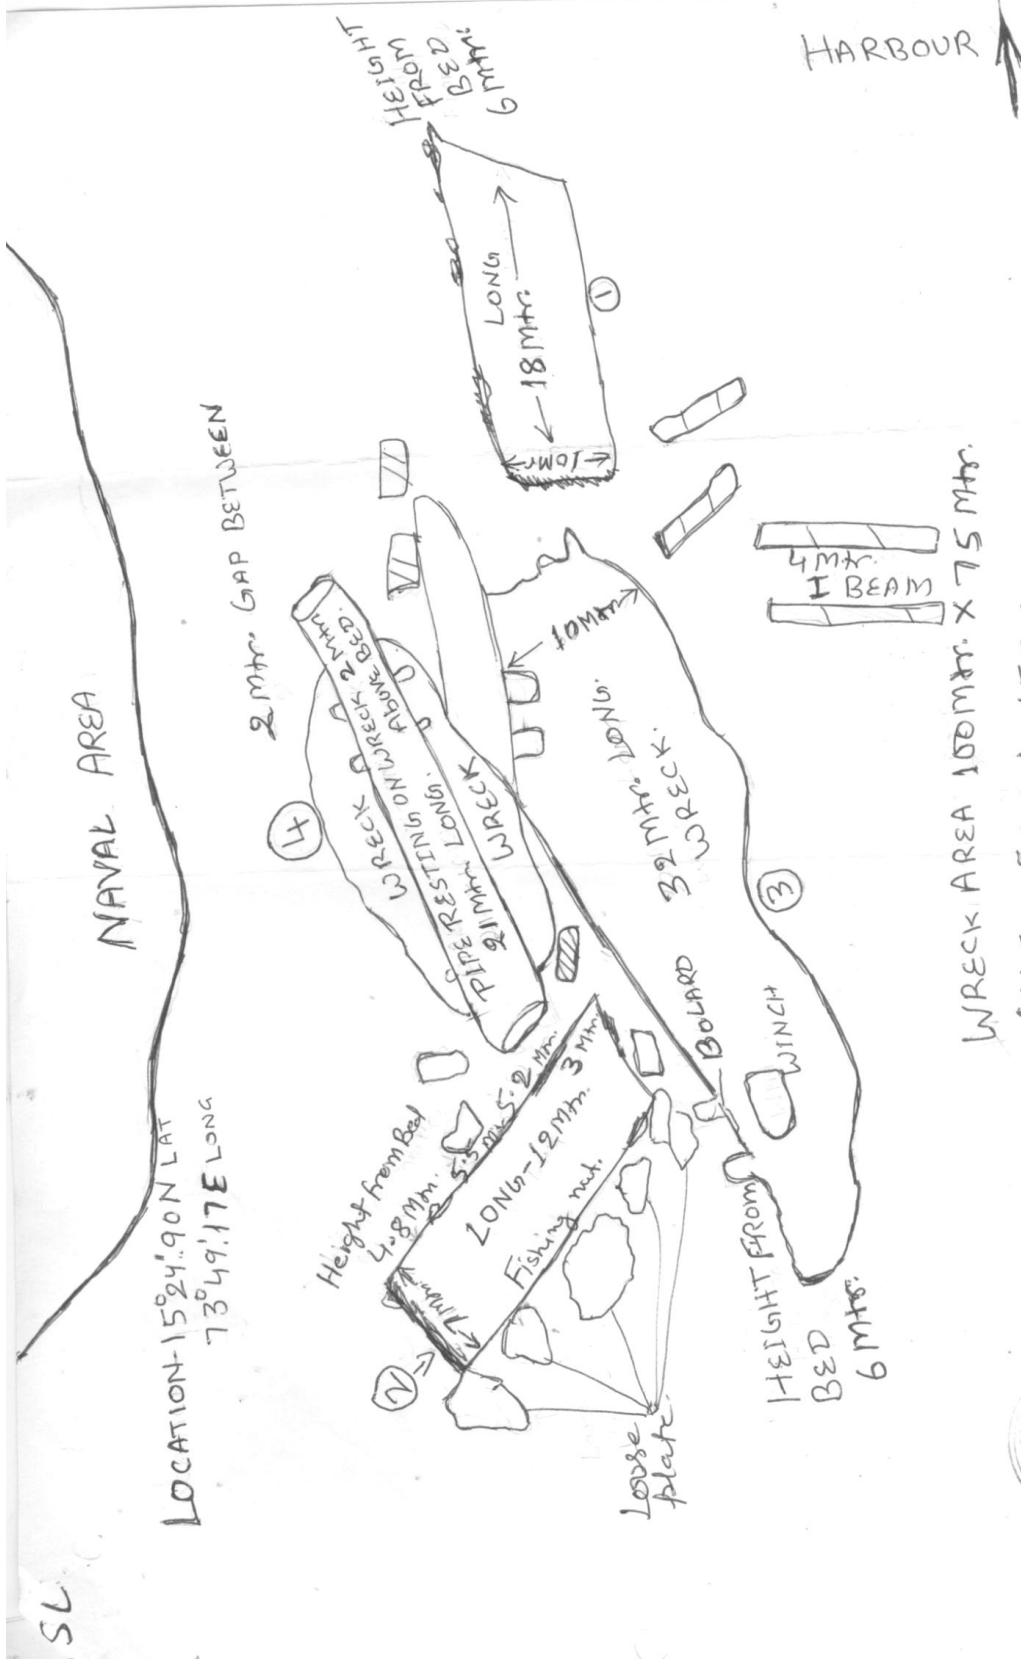
Enclosed : Sketch of wreck

Divers inspected the wreckages area and noticed that there are 04 nos. of vessel and sunken all together .The plates wreck are scattered and resting on each other . The wrecks are seems to be approx. 20 years old in the vicinity.

LOCATION-15°24'.90" N LAT
73°49'.17" E LONG

WRECK AREA 100 Mtr. X 75 Mtr.
SILT - 5 CM TO 15 CM.
HEIGHT FROM SEA BED 6 Mtr.
WATER LEVEL ON 7 OCT. 2015
6.8 Mtr.
AT - 11:00 AM.

Suggestion : The wreckages of the sunken vessel can be removed only by underwater cutting and floating crane barge to lift it .
